ETHEL STREET,
CANTON
DECARBONISATION
RENDER PROJECT

Ethel Street, Canton, Cardiff CF5 1EJ.

The demonstration works were carried out on four houses 2 & 4 then 8 & 10 Ethel Street, with funding and in partnership with Taff Housing and ORP

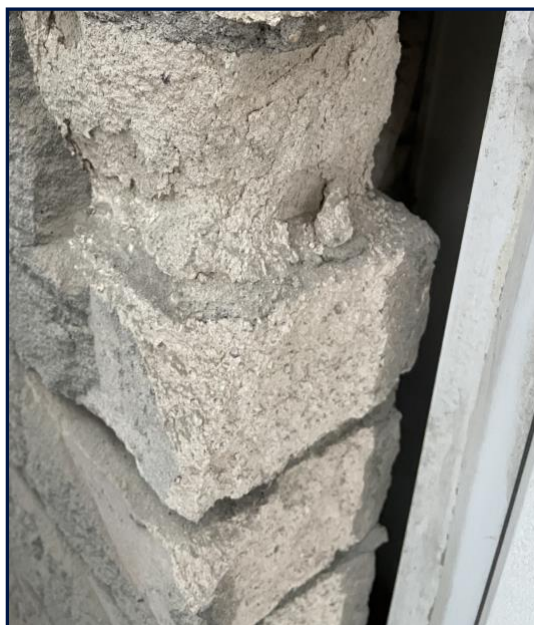
The result is a void behind the brick leaf of approximately 100mm x 100mm extending up both sides and over the top of each window. The gap / joining-moment to the reveals, sides and heads, was covered by cement render approximately 10 mm in depth.

When the 10 mm depth of cement render was removed to the reveals it opened the gap and it became possible to look into the void and see the back of the internal reveal plaster board.

It is probable therefore that this void and minimal cement cover to the outside created such a significant cold-bridge to have negated the entire purpose of fitting the double glazed units.

- The issue surrounding the windows has been satisfactorily resolved by Vivus Solutions Ltd during the project.
- The solution was designed to be simple, cost effective and replicable.
- They remain easily removable for future upgrade and replacement.
- The lack of solidity through insufficient fixings, has been resolved and all windows are now firmly located in place.
- Rain and moisture ingress has been stopped.

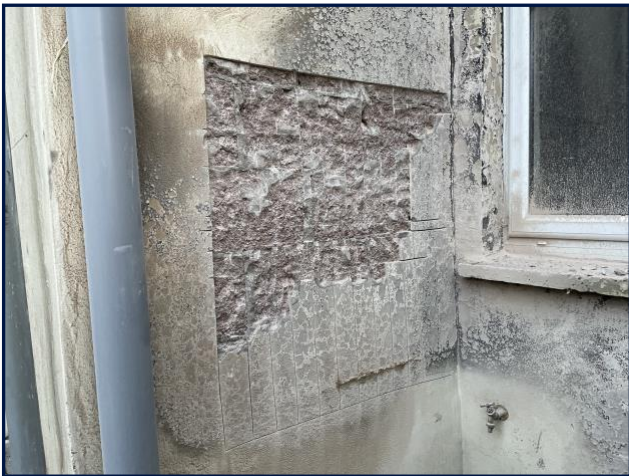
They are all coated in extremely hard and impervious cement and over-coated with an impervious cream coloured paint.

The entire build up of materials have very poor thermal efficiency, are cold to touch and display surface condensation to both internal and external faces, actually gathering to a degree where it runs down the wall.

A timed and measured attempt at removing the cement render was undertaken with two experimental approaches at the removal. Neither proved successful and the process has shown that removing the cement is impossible for time and substrate damage reasons.

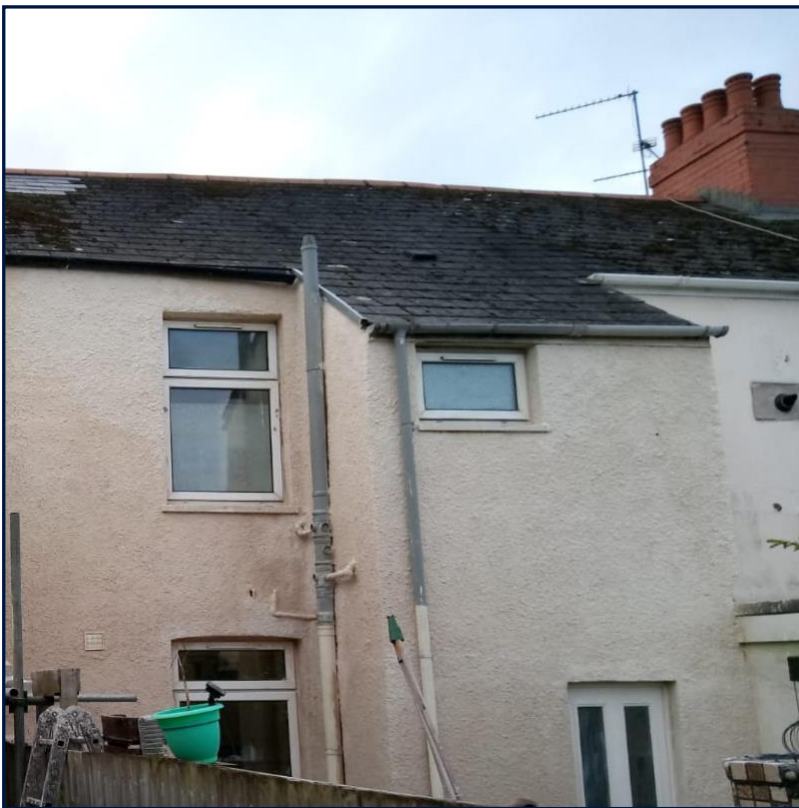
The slight discolouration shown is due to the photograph being taken the day the scaffold was being removed at the end of February 2023. The walls had not finished their drying process.

The method is cost effective and replicable. The evidence from the project shows the method to have achieved the aim so far.

There is no external condensation.

There is no internal condensation.

The render appears to be successfully adhered to the wall.

The finish appearance is the same as the rest of the building.

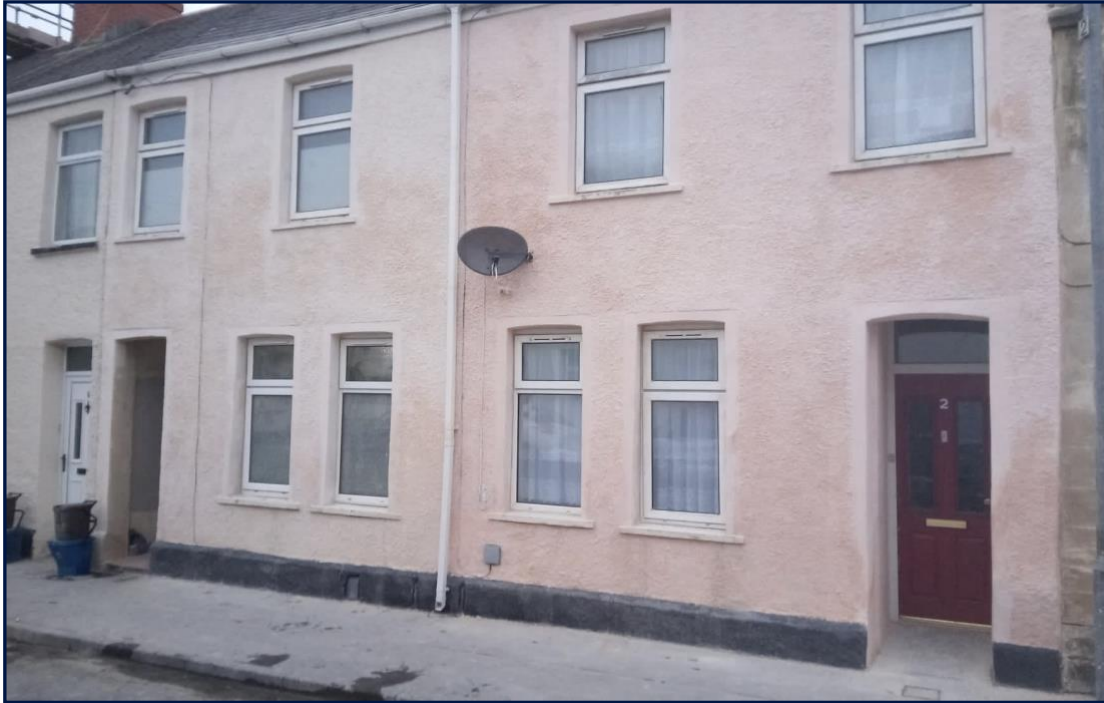
The external appearance is a traditional vernacular finish - enhancing streetscapes and therefore the houses have not been changed by retrofit measures other than improvements in aesthetic quality. The historic nature and integrity of the buildings has only been enhanced. The insulation performance does not require the considerable ruination of the façade and streetscape by the addition of flat slab insulation materials and modern render.

The visible increase in depth of render over the cement pebbledash is imperceptible.
